# Levee and Shoreline Analysis Task

*SR 37 Design Alternatives Assessment*  
*SR 37 Policy Committee – March 1, 2018*

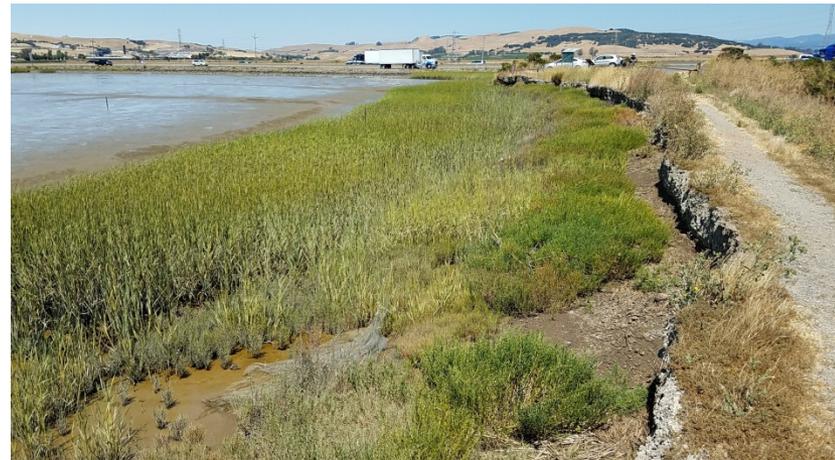
# Critical Shoreline

Shoreline segments that provides direct flood protection to SR 37

- A1: Novato Creek levees
- A2: Petaluma River levees & Port Sonoma shoreline
- B1: Tolay Creek/Tubbs Island levees
- B2: SR 37 from Sonoma Creek to Napa River (incl. Mare Island)
- C: SR 37 from Novato Creek to I-80

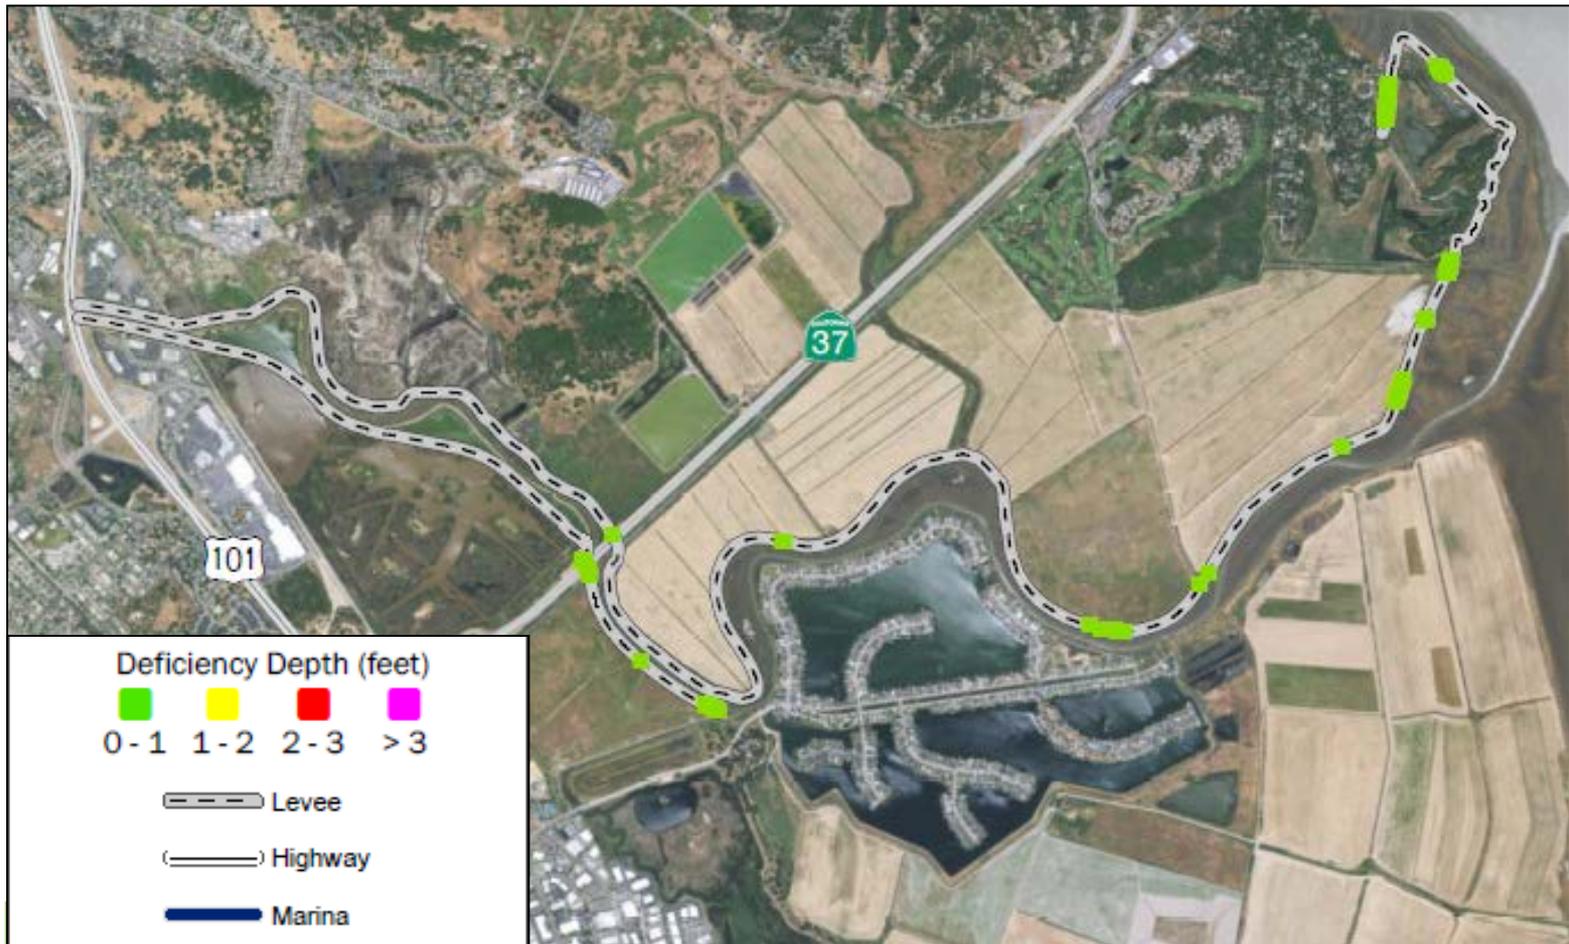
# Overtopping Deficiencies for A1

Present Day 10-yr Storm/2050 1-yr Storm

- 2% of shoreline is deficient
- 45% of shoreline is deficient during 100-yr storm in 2050

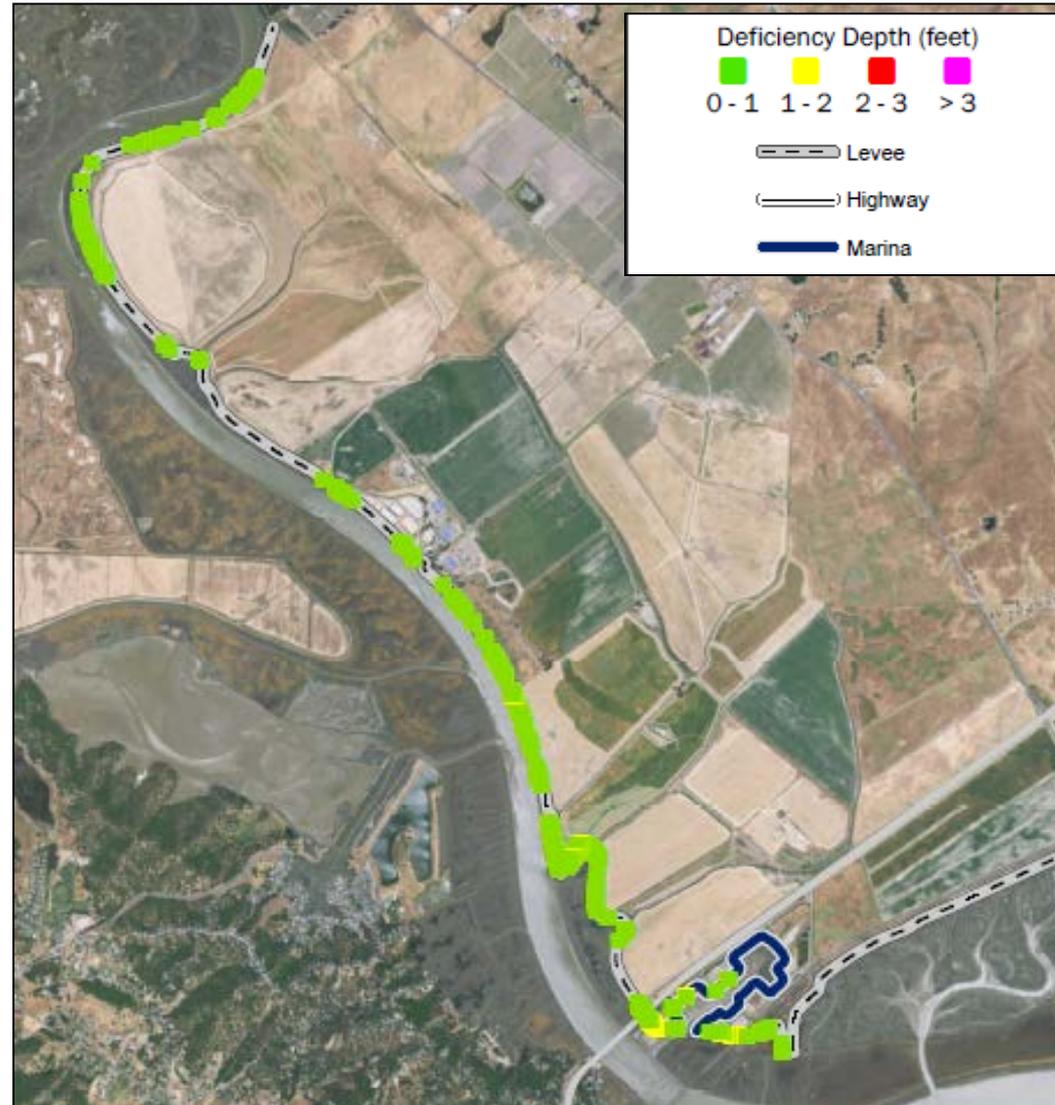
# Overtopping Deficiencies for A2

Present Day 10-yr Storm/2050 1-yr Storm

- 11 miles of levee protect 4 miles of highway
- 11% of shoreline is deficient
- 80% of shoreline is deficient during 100-yr storm in 2050

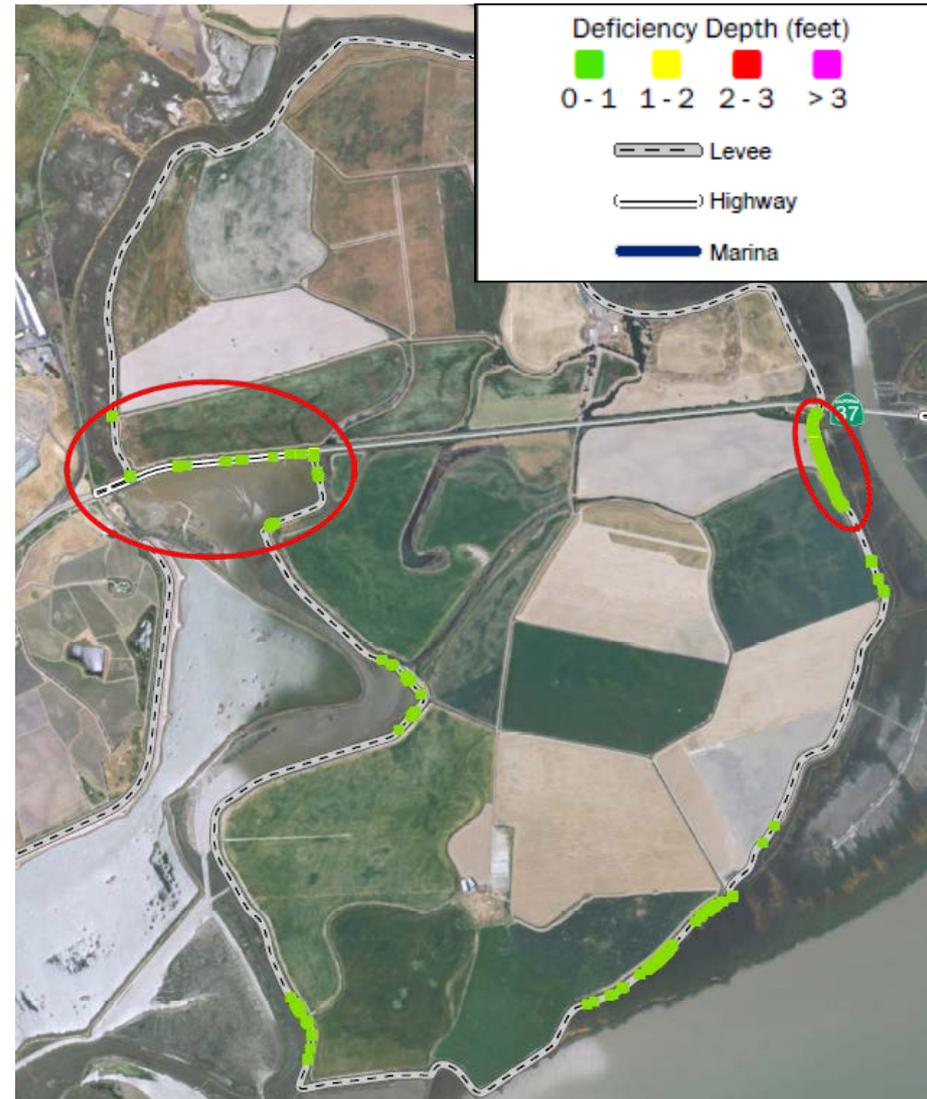
# Overtopping Deficiencies for B1

Present Day 10-yr Storm/2050 1-yr Storm

- 11 miles of levee protect 2 miles of highway
- 6% of shoreline is deficient
- 80% of shoreline is deficient during 100-yr storm in 2050

Tolay Lagoon:

- 2800 ft flood wall along roadway
- 3500 ft levee improvement along adjacent levee segments

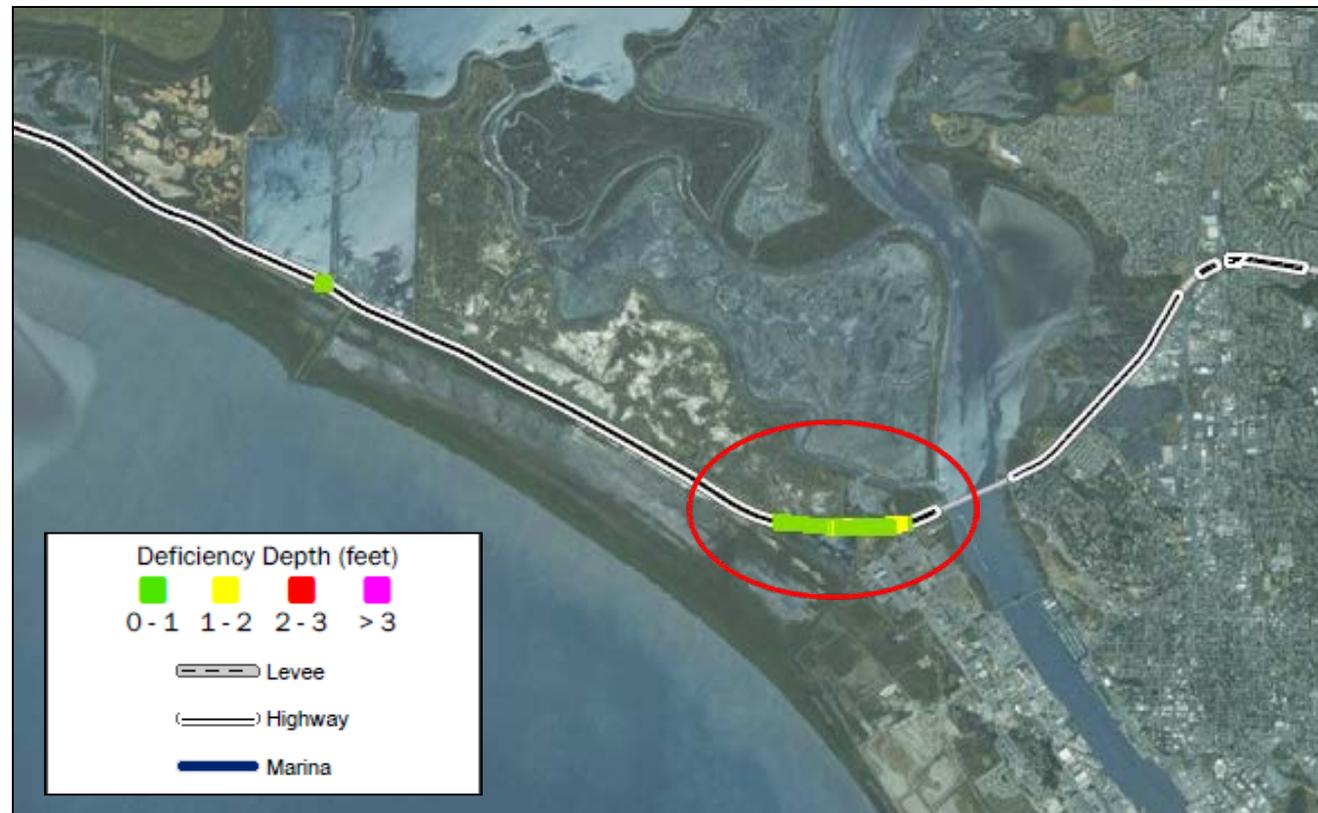
# Overtopping Deficiencies for B2&C

Present Day 10-yr Storm/2050 1-yr Storm

- 5% of shoreline is deficient
- 40% of shoreline is deficient during 100-yr storm in 2050

Mare Island:

- 1600 ft flood wall along south side of roadway
- Flood waters come from south side

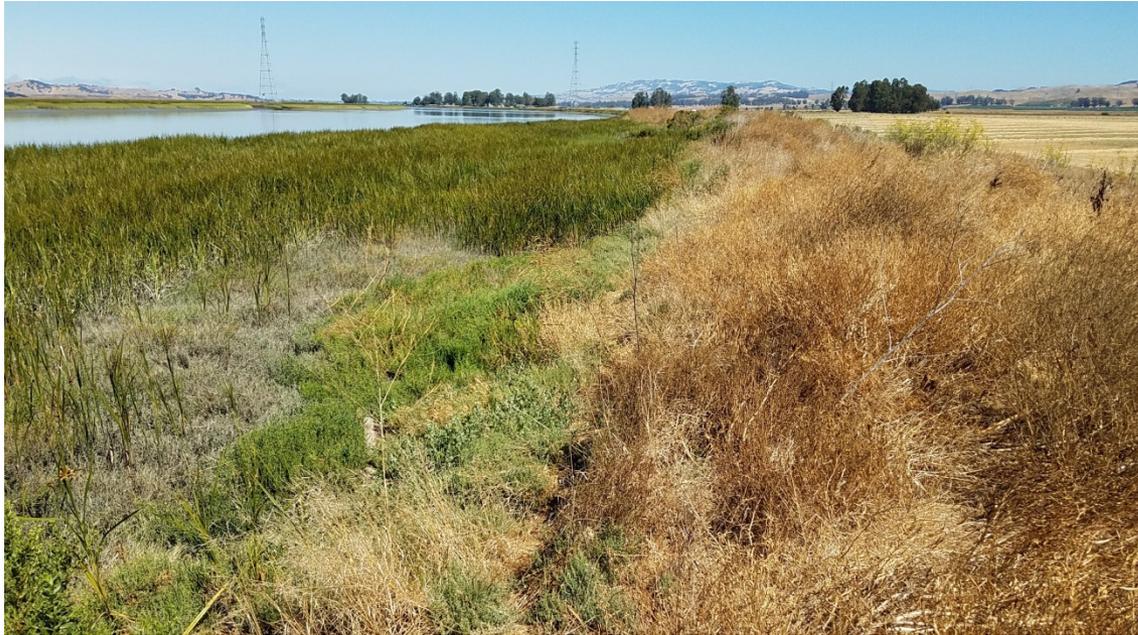
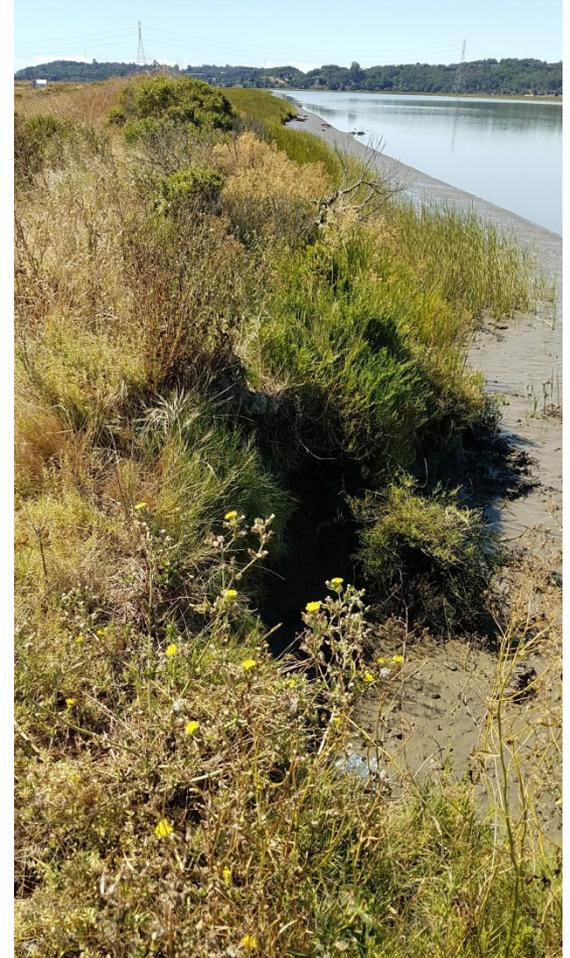
# Minor Shoreline Deficiencies

- Lack of patrol road
- Insufficient geometry
- Excess vegetation
- Animal burrows

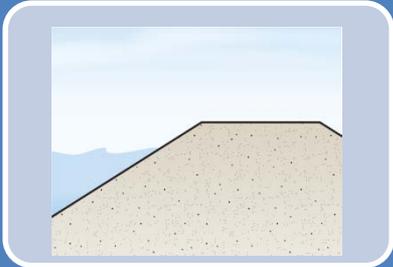
## Levee Improvements

- Raise elevation of existing levee
- Stability berm on landside slope
- Seepage berm on landside slope
- Erosion protection on waterside slope

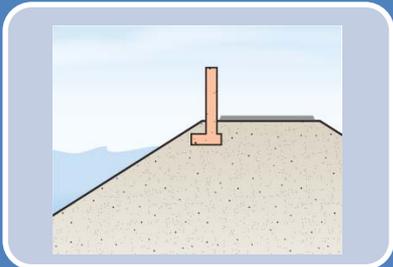
## Shoreline Improvements

- Concrete wall along edge of roadway
- Sheet pile wall along edge of roadway
- Install drainage

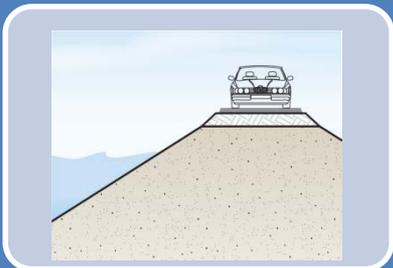
## Roadway Improvements

- Raise elevation of roadway surface

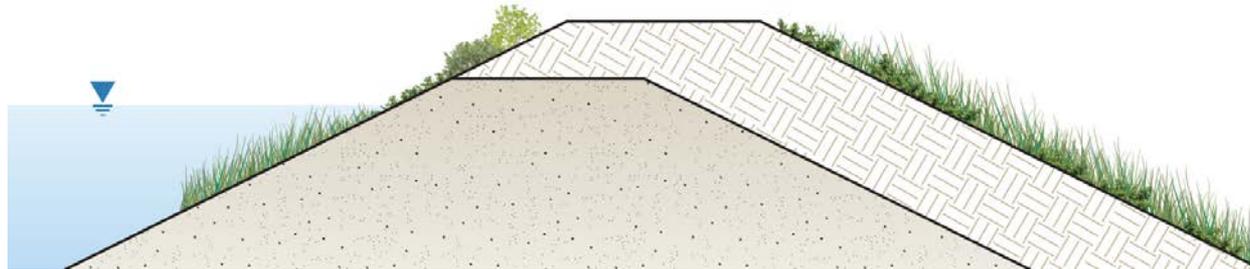
Overtopping – raise crest

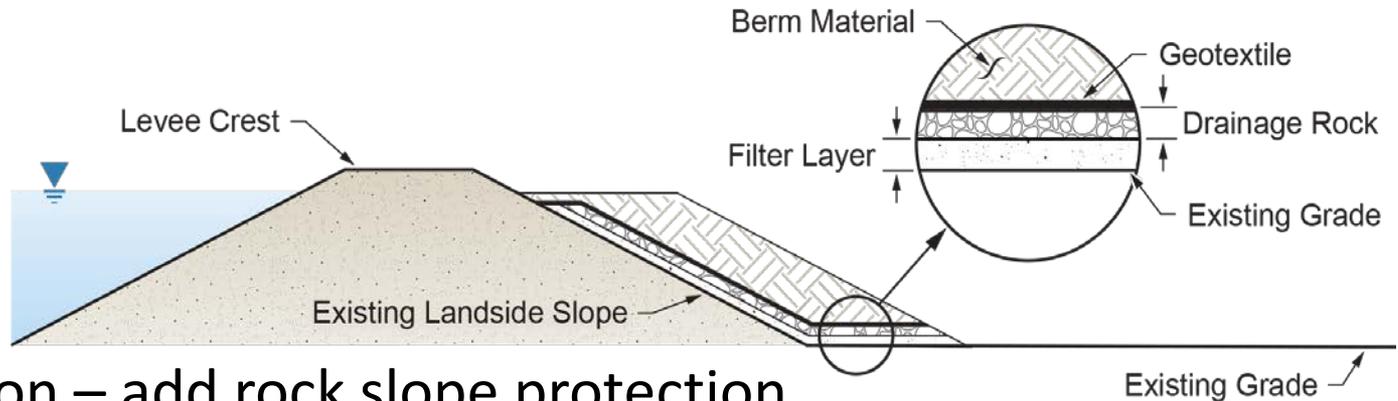
Stability and seepage – add stability berm

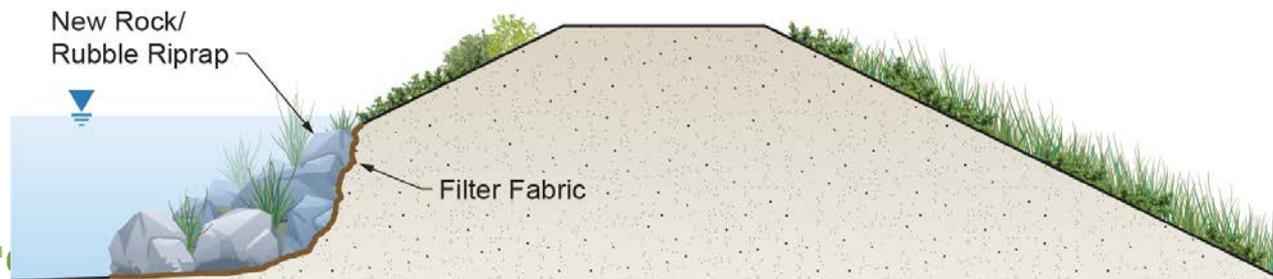
Erosion – add rock slope protection

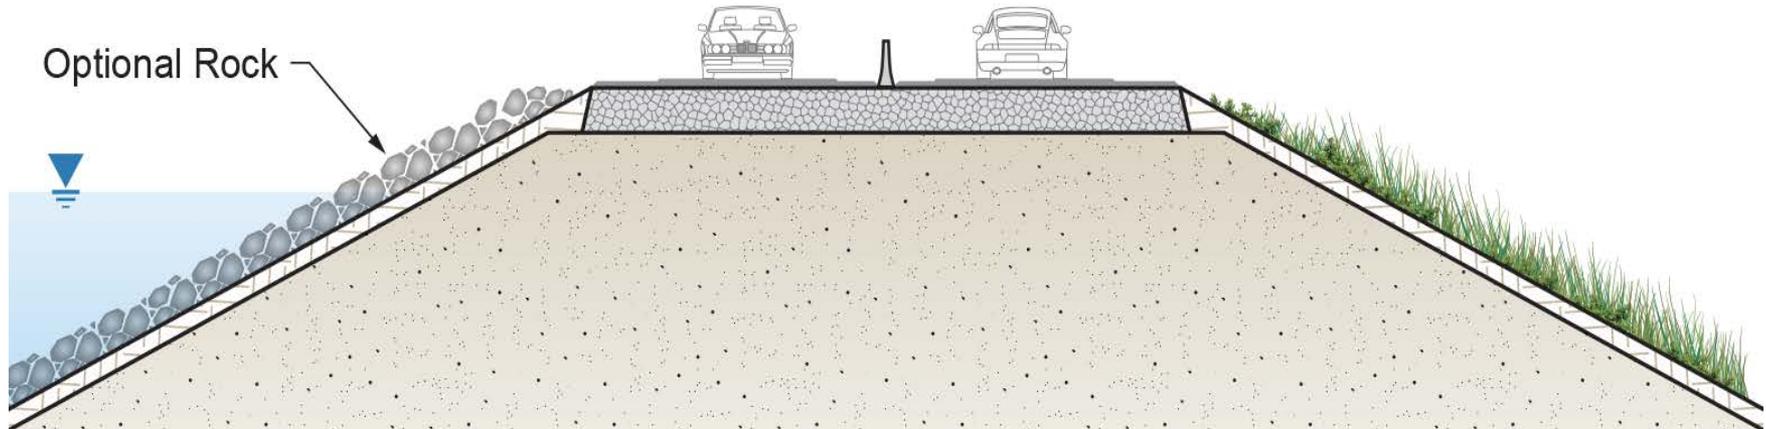
# Raise Roadway

- Need to tie into existing roadway elevation
- Only appropriate where overtopping deficiencies are small
- May not be feasible due to traffic impacts

Applicable to Mare Island and Tolay Lagoon low spots
